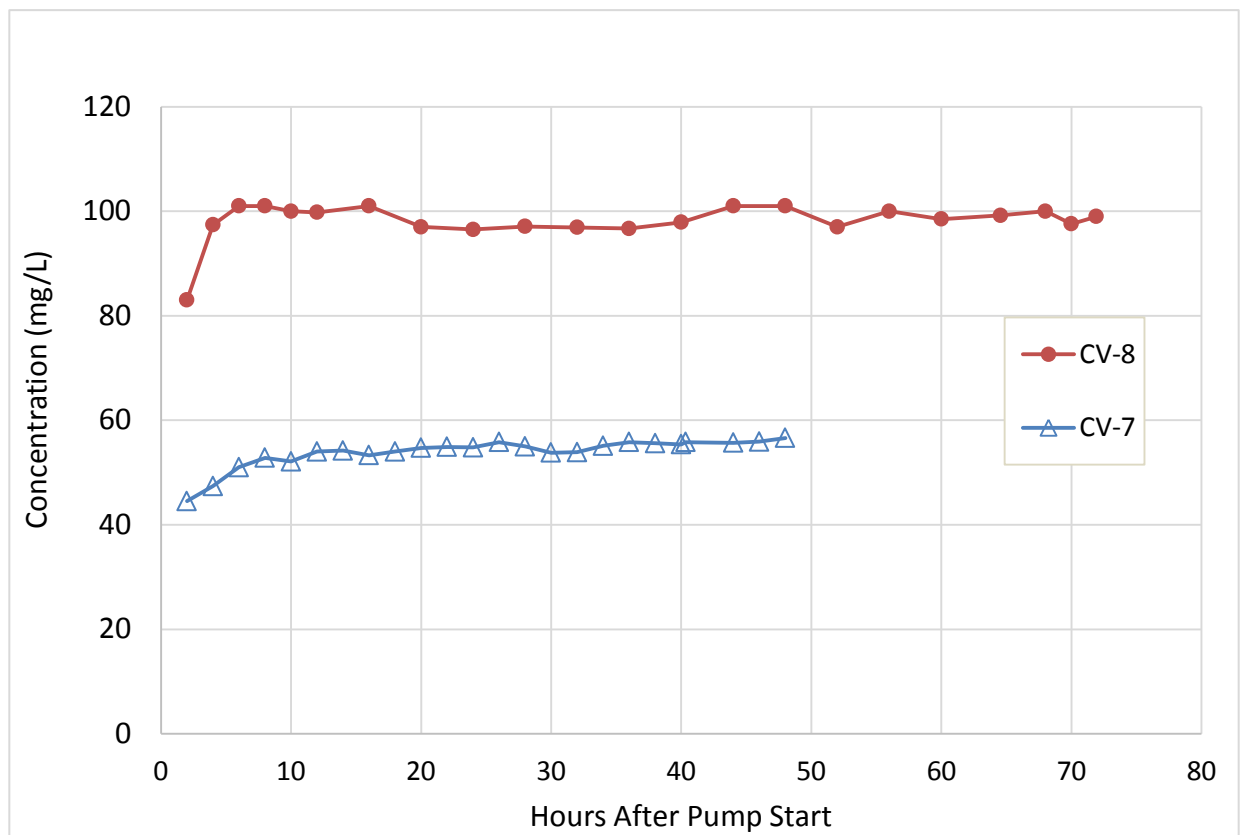
Figure 1 - Lithium concentrations in brine extracted during pumping tests at CV-7 and CV-8
